Project Coordination Request for Historical Studies Project

Roadway Name: Blanco Road

Cultural Resources Constraints Analysis Report - Supplemental

Blanco Road Phase II from West Oaks Estates to Borgfeld Project
Bexar County, Texas

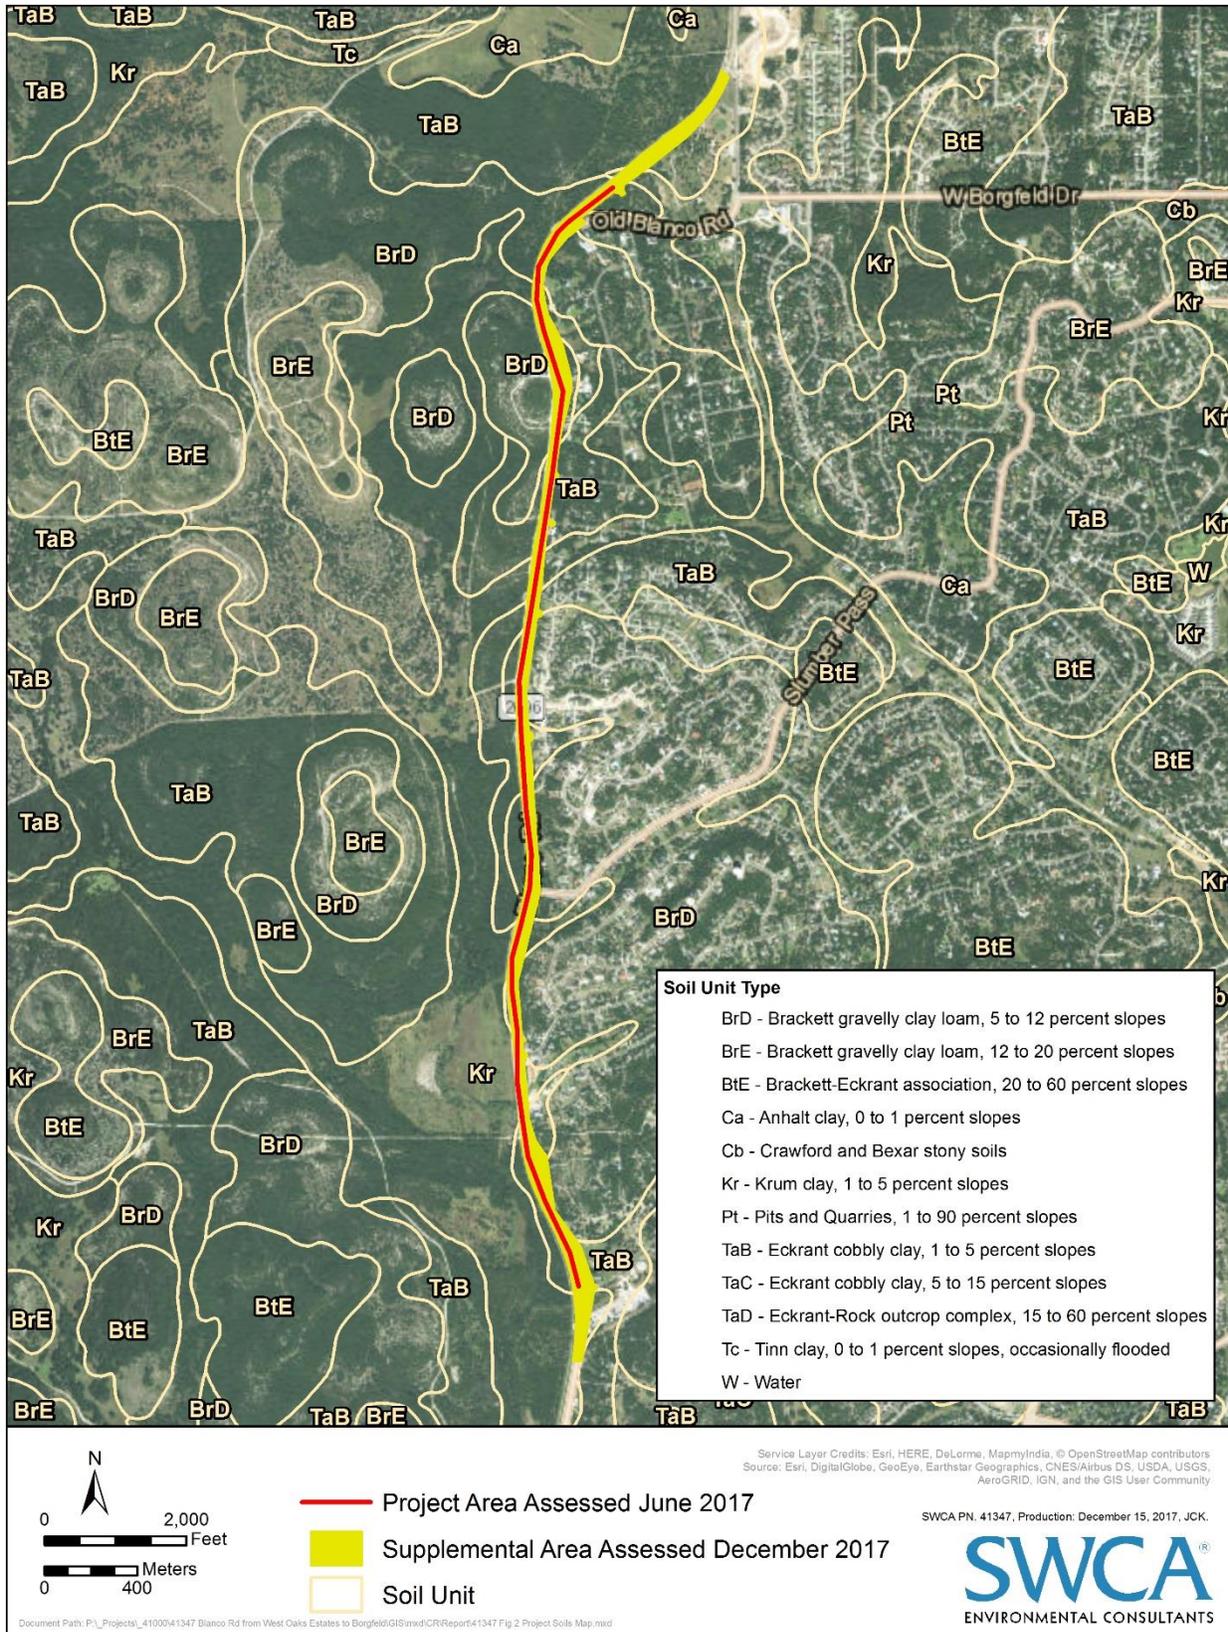
Figure 2. Aerial view of project area with soils overlay.

The two proposed work area extension cross xx soil series as mapped by the U.S. Department of Agriculture Natural Resources Conservation Service (NRCS 2017; Figure 2):

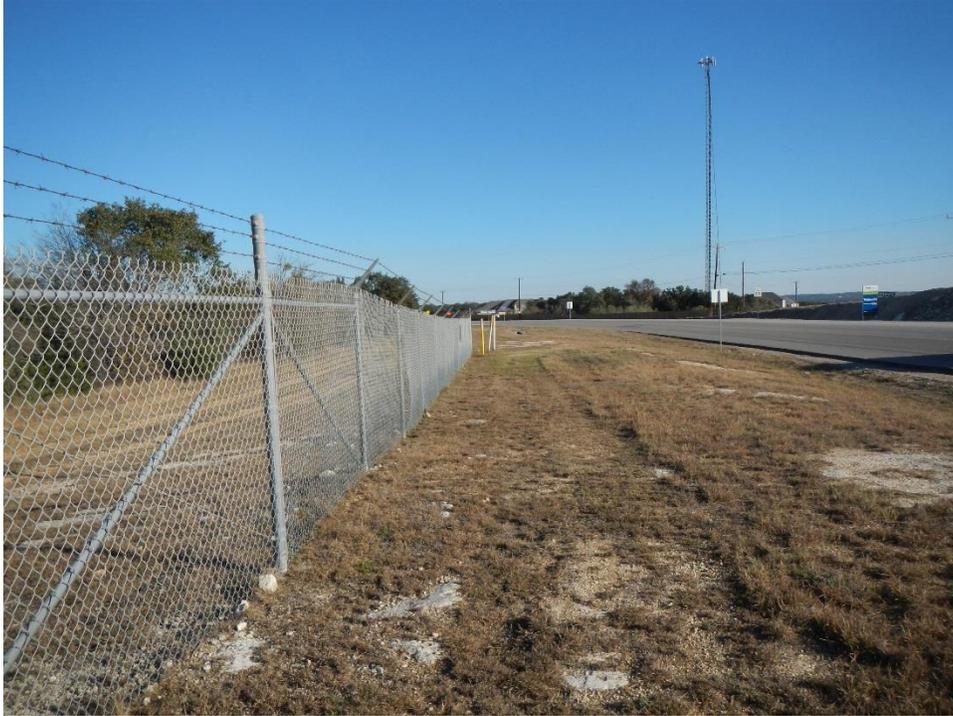
Photo Area 1-1. Reported location of site 41BX1254, west side Blanco Road ROW, facing north.

The known cultural resources that are plotted on the Sites Atlas within 1 km of the supplemental work areas also remains the same as that found in the prior report (Atwood 2017; Figure 3; Tables 3 and 4). The only adjustment is that the northern extension now shows as being within 100 feet of site 41BX1254 (Table 3). This site was associated with the karst inventory study discussed above. The archaeological materials were located inside the karst features and primarily consisted of early 20th century artifacts, although several prehistoric Archaic Period dart points were also found. The THC agreed with the finding that the site was not eligible for NRHP-listing. SWCA ecological staff searched for evidence of the karst features during a field inspection performed on December 11, 2017 but found no evidence they remained intact (see Photos 1-1 and 1-2).

The earlier report (Atwood 2017) recommended a reconnaissance survey and photo documentation of the project area in order to demonstrate the level of disturbance. A visit on December 11, 2017 by SWCA ecologists performing a karst survey confirmed that the existing right-of-way generally consists of cleared, grassy shoulders adjacent to the existing paved road. Photographs in this document illustrate the heavy degree of land disturbance that typify the entire Blanco Road alignment (see Photo Areas 1-7). SWCA maintains the earlier finding that multiple prior cultural resources field surveys and the limitation of project activities to the cleared ROW have sufficiently examined the project area. Further cultural resources studies are not warranted unless the project design changes to extend beyond the locations reviewed.

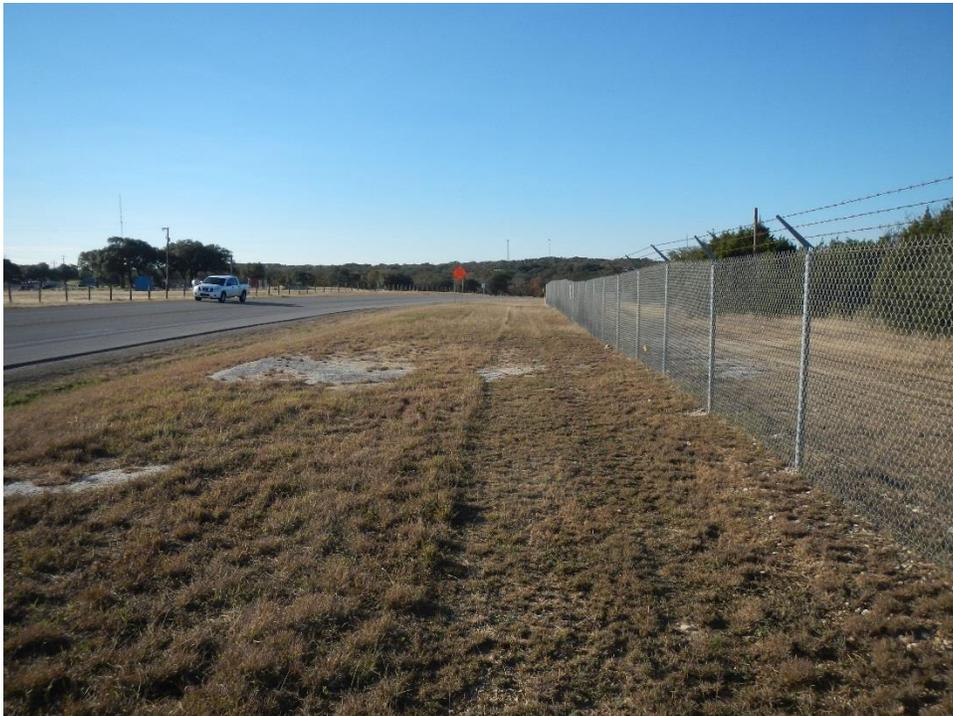
Photo Area 1-2. Reported location of site 41BX1254, west side Blanco Road ROW, facing south.
